MEMORANDUM

Project: Gold King Interim Water Treatment Plant

Reporting Period: December 21 - 27

Report No.: 2

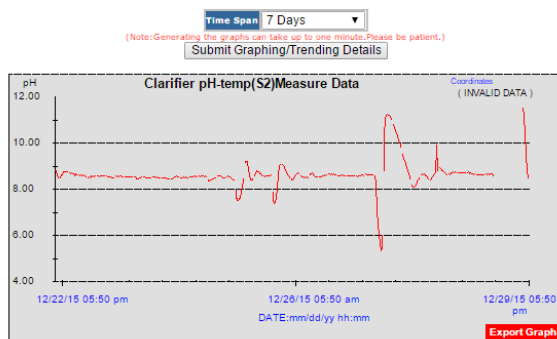
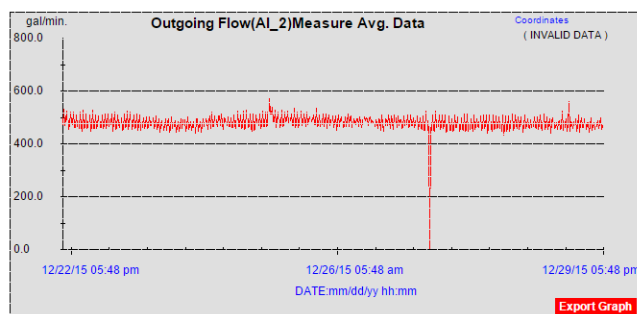
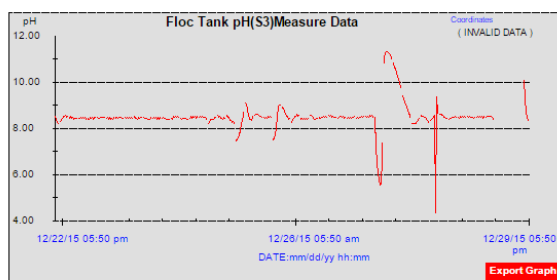
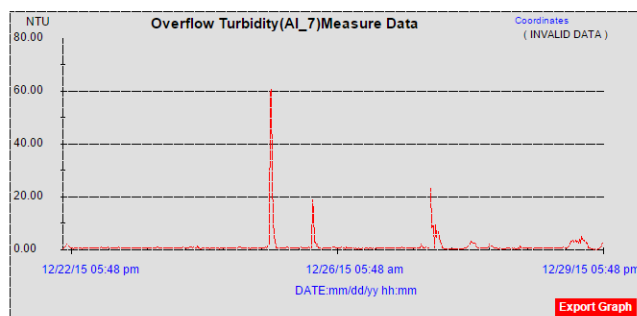
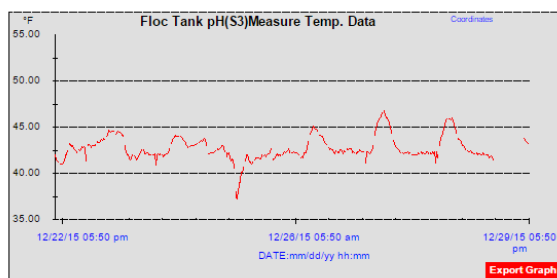
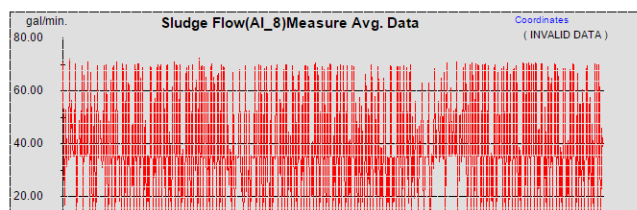
- The following graphs provide trending information from the previous 7 days of the Flow Circuit and Lime Circuit PLC's at the Gold King IWTP. Over the reporting period (12/21 – 12/27 inclusive) Alexco treated 4.9 million gallons at an average of 525 gpm, resulting in 40 gpm to the sludge storage system and 485 gpm to the discharge line.

- As shown in the pH graphs above, a plug developed in the intake to the peristaltic lime feed pump for a duration of less than 3 hours on 12/26. The obstruction was immediately identified and the on-site operator removed the obstruction in the feed line and restored lime slurry flow. As a result of the normal operation of the automatic lime slurry feed system, the concentration of the lime in the lime reagent feed tank overshot the target and the pH of the treated water spiked to pH 1.5-2.5 standard units greater than the setpoint (pH 10-11.5). The section of line from the tank to the intake to the peristaltic pump has been identified as requiring higher frequency preventive maintenance, which will be conducted biweekly.

- A large snow storm hit on 12/24 and created very difficult access conditions through 12/27. The intensity of the storm can be deduced from the decrease in the temperature observed in the feed to the plant as large amounts of snow fell into the open pond feeding the plant. This also caused intermittent partial blockages of the feed intake from the pond to the plant resulting in increases in the pond level of about 0.15 psi or about 3 inches of head. The treatment dosing system responded well throughout the storm to the variable flows to maintain quality of discharge as indicated by pH, but the reduced flow rate likely contributed to the development of the obstruction in the lime feed line in the immediately preceding bullet. We believe that the combination of the preventive maintenance on the feed line (reaming out the intake port to the feed line) and if necessary reducing the diameter of the feed line, will be sufficient actions to maintain acceptable quality of the discharge.

- Alexco attempted to switch over to the more robust compressor system (dual compressors with larger pressure vessels) for providing air pressure to the plant, but experienced several circuit overload conditions (tripped breakers) which caused the three turbidity events shown on the graphs. These events resulted in reduction of sludge flow to the sludge storage area which were limited in duration. The larger compressor system has been taken off line until grid power is established and it will be restored at that time, providing higher quality air to the pneumatic sludge control system.

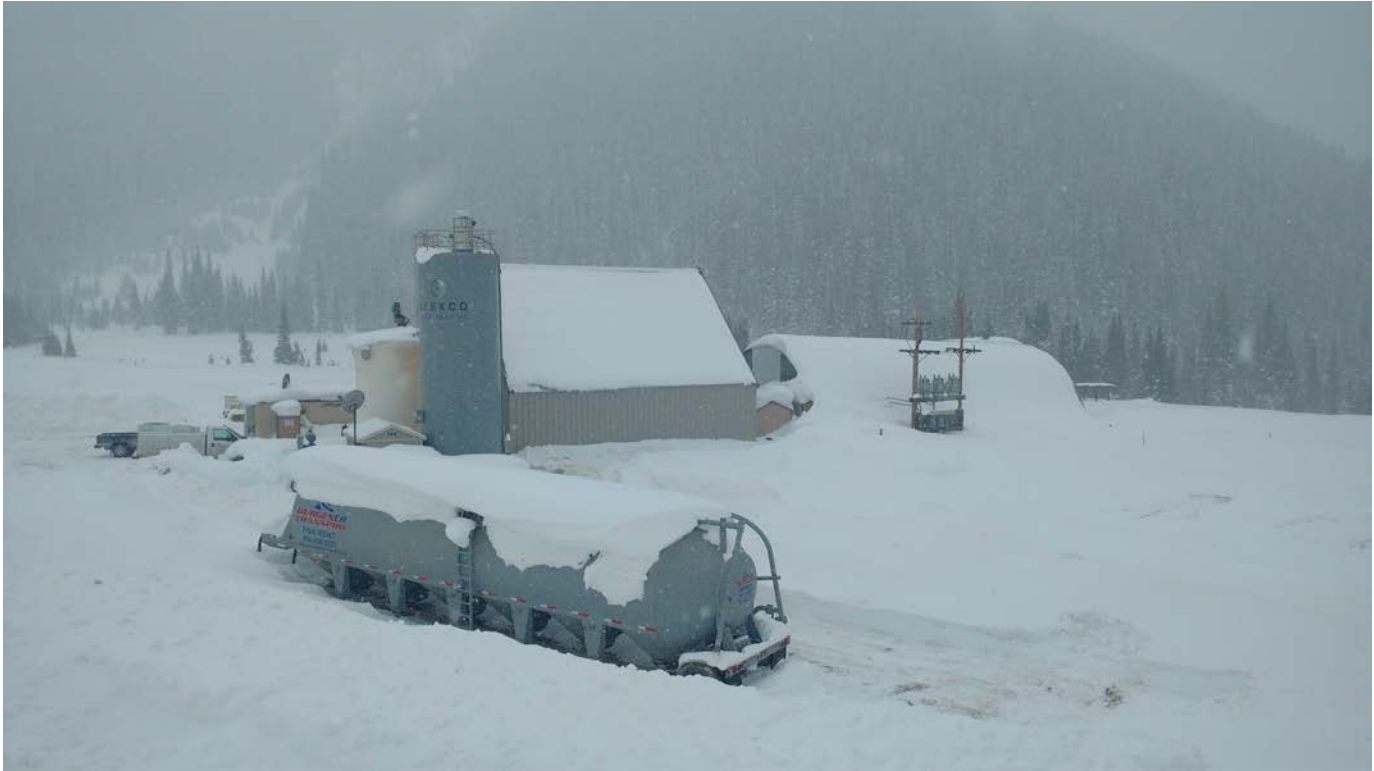
Photo 1 – Taken 12/29/2015, view of IWTP from upper road.

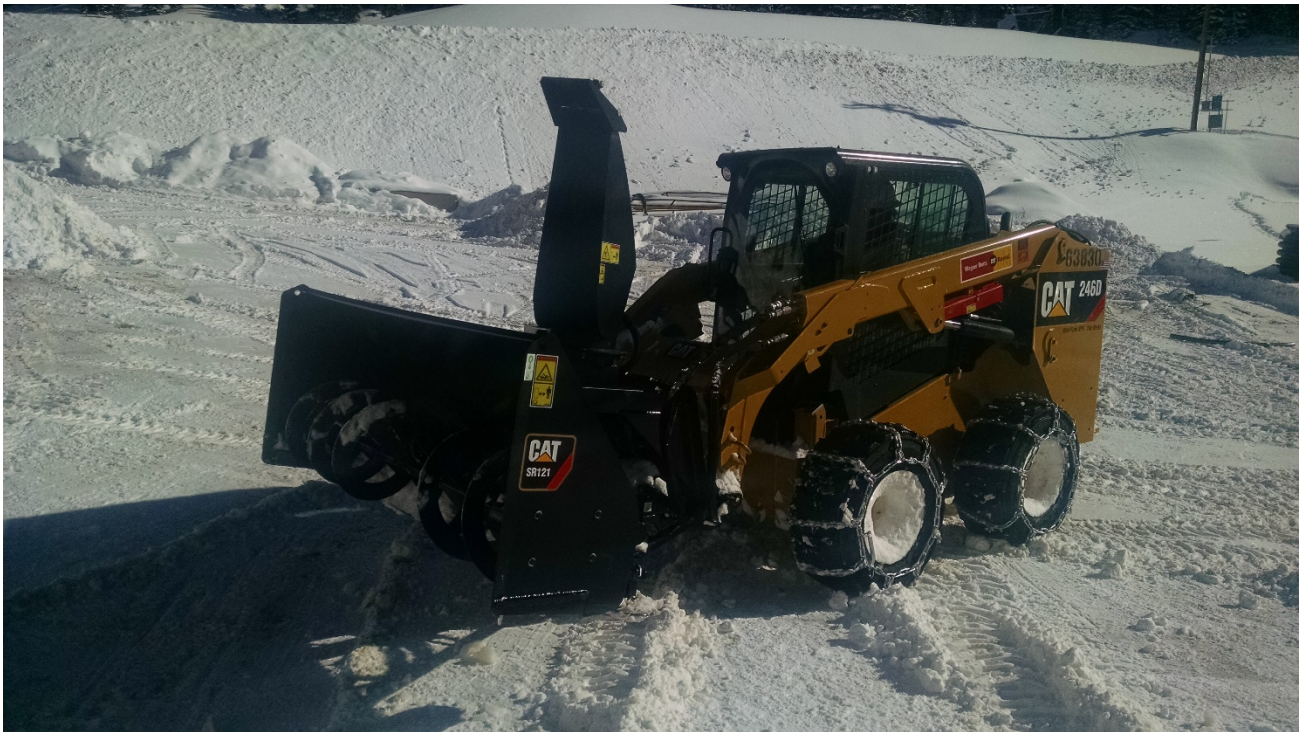
- Alexco currently employs two FTEs who live in Silverton that oversee operations at Gold King IWTP.
- Alexco has rented a skidsteer/blower (see Photo 2) to support snow removal throughout the winter. Alexco has used this equipment to clear Jane Legge's driveway on two occasions at EPA's request.
- Alexco project manager and project director have inspected the site during this reporting period to develop this weekly report and conduct the necessary evaluations of the treatment system.

Photo 2 –Alexco's snow removal equipment.

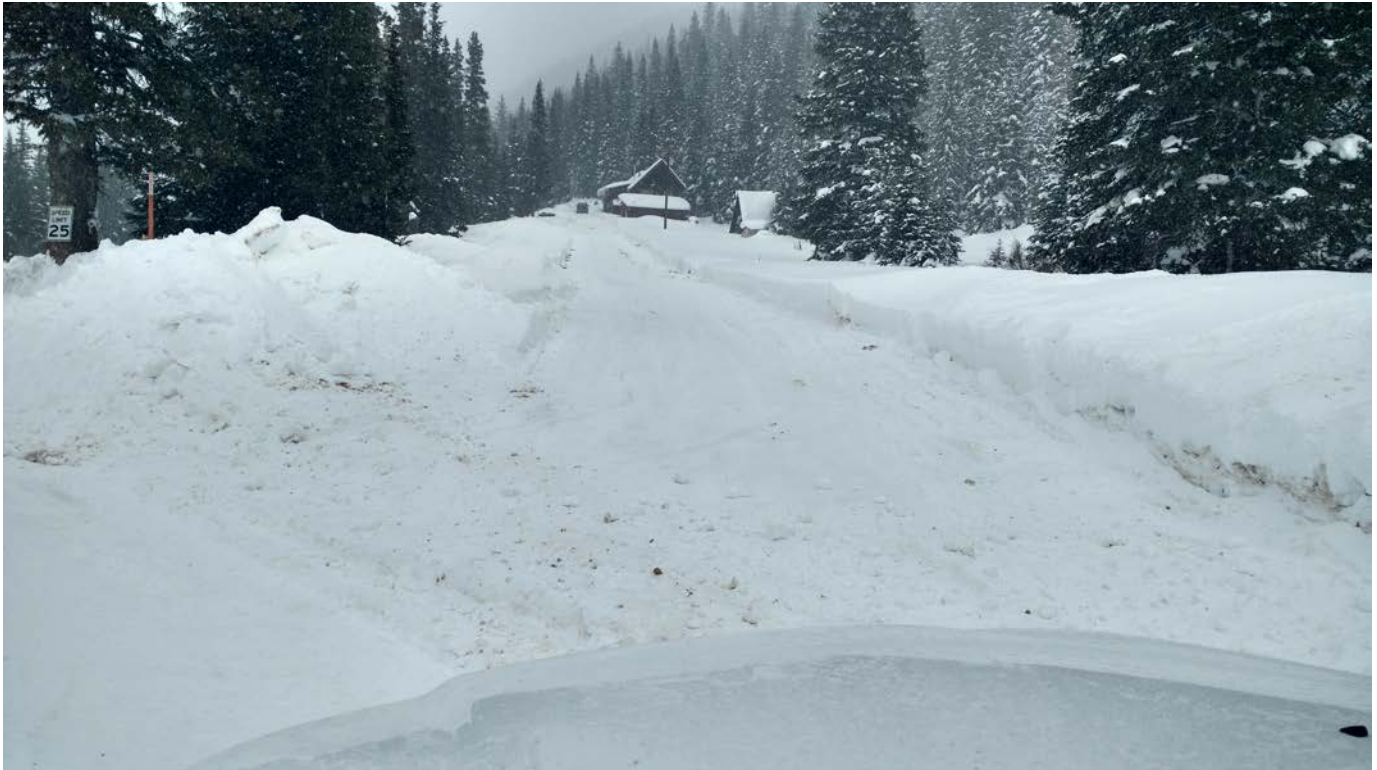
Photo 3 –Snow removal from Jane Legge’s driveway. Taken on 12/29/2015.
